South Dayton Dump OU 1 Hot Spot Issues
Ohio EPA
April 17, 2012

Ottoson Solvents Drums

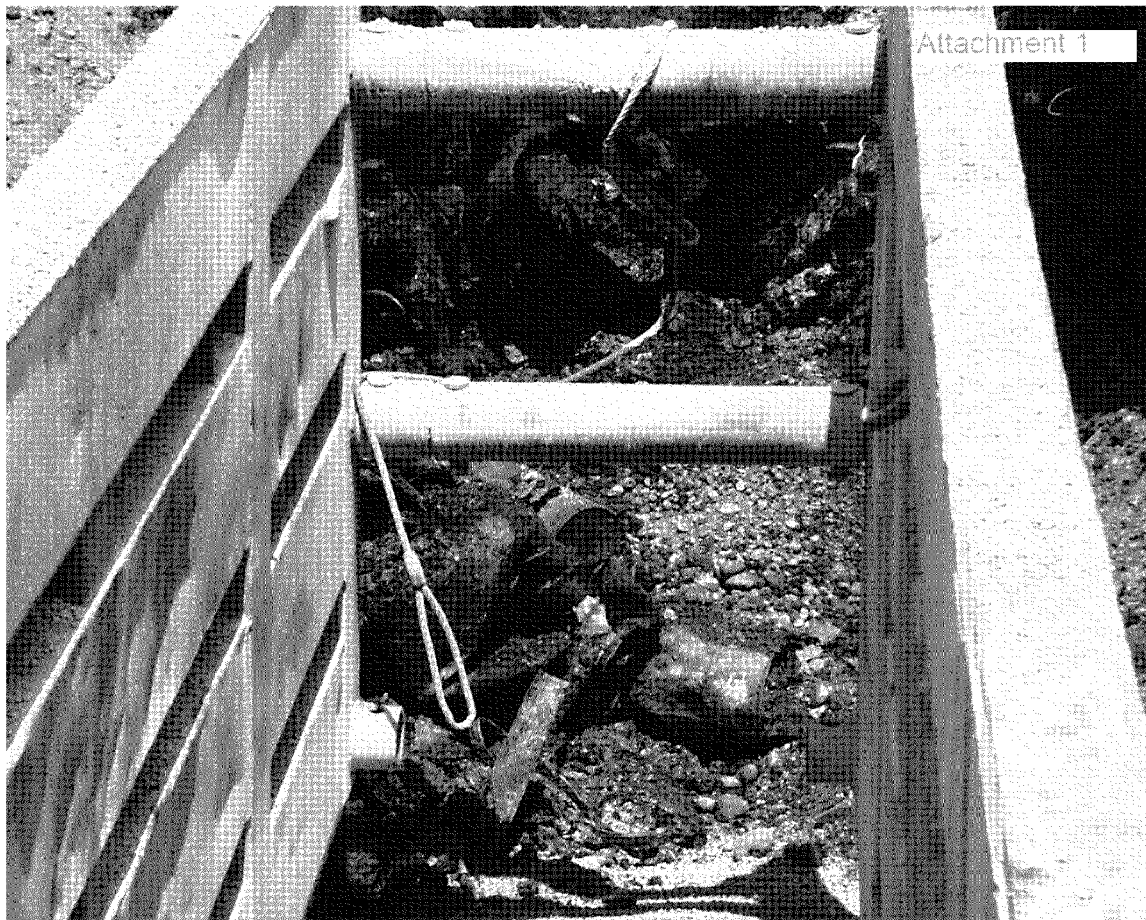
Ottoson Solvents was a drum recycler that began operation in the late 1950s on approximately two acres of what is now part of the Valley Asphalt property. Ottoson Solvents bought used drums from companies and repainted, refurbished, and resold the drums. Reportedly, if the drums contained residuals, the residuals would be emptied into another drum and, when that drum was full, it would be buried.¹ The drums were first encountered in 2000 during excavation for a sewer line at Valley Asphalt. Five drums were excavated from the shallow sewer trench before the excavation was halted. A number of other drums visible in the sewer excavation were left in place (see Attachment 1).

Photograph taken by: Dale Farmer, Ohio EPA Emergency Response, Southwest District
Date: May 17, 2000

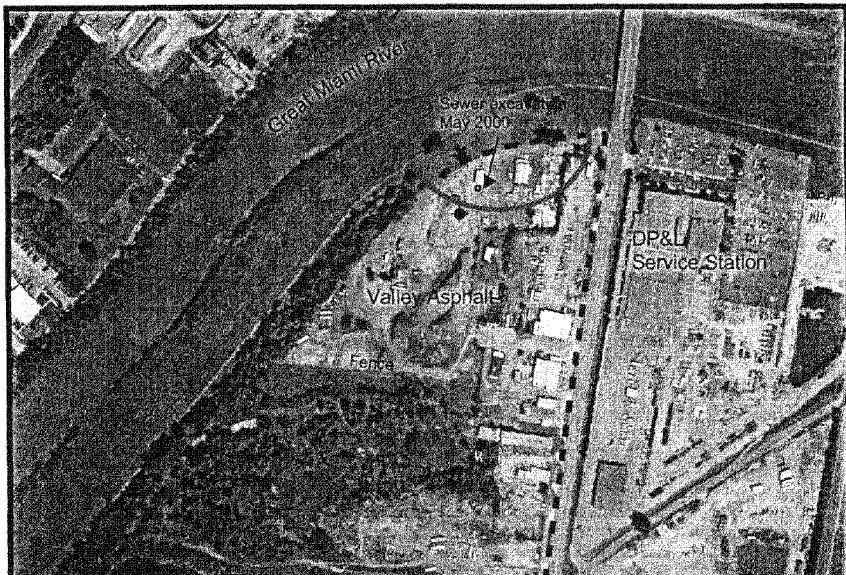
Attachment 2
From Figure 1, ASAOC

Both the presence and location of the Ottoson Solvents drums were known at the time the Administrative Settlement Agreement and Order on Consent (ASAO) for Remedial Investigation/ Feasibility Study (RI/FS) of the Site was negotiated. Specific language requiring investigation and evaluation of hot spots was incorporated throughout ASAO as a result, and their location, identified as "Sewer Excavation May 2000," was depicted on Figure 1 of the ASAO (see Attachment 2). The location of the drums was confirmed during the limited RI when test trench TT-21 was excavated at what was assumed to be the perimeter of the drum disposal area (see Attachment 3). The test trench confirmed the presence of drummed waste at the location identified in the ASAO (see Attachment 3).

The Ottoson Solvent drums are located in the northern end of the existing business area being considered for the specialty asphalt (Matcon) cap. As can be seen from Attachments 2 and 3, the location of the drums is near the GMR, in an area of shallow groundwater table fluctuations and flow reversal during high water events. As outlined above, it is evident that the drums contain a variety of principal threat wastes, are near-surface and readily accessible, and based on all available information, appear to be limited to the northwestern edge of the two-acre area leased by Ottoson Solvents. Unlike the vadose zone VOC hot spots, there is no hope that the wastes in the drums will eventually be removed by an active landfill gas extraction system.

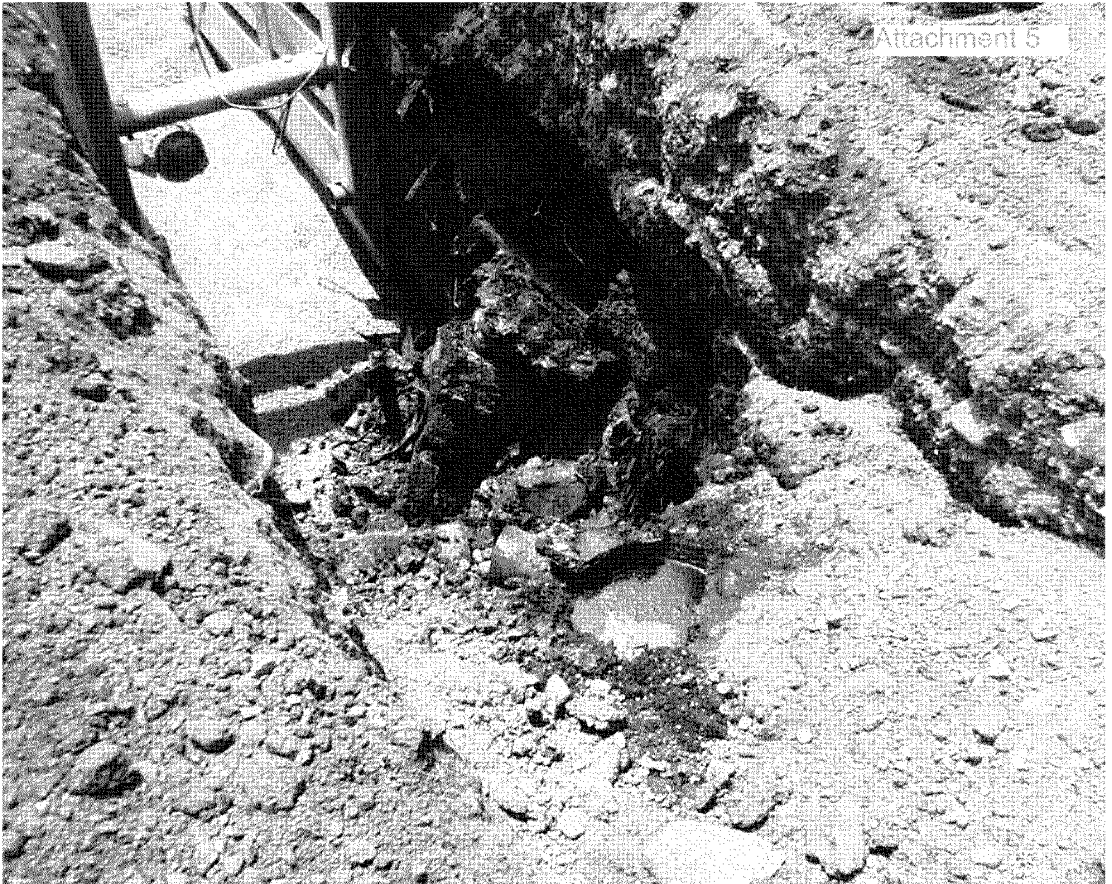
The drums contain liquids. Pictures of the 2000 sewer line excavation show a decapitated drum containing liquids in the path of the excavation (see attachment 5). The drum from the 2008 test trench contained 26% liquid based on laboratory analysis.

Photograph taken by: Dale Farmer, Ohio EPA Emergency Response, Southwest District

Given the above, the Ottoson Solvent drums should be removed from the Site. Their location is known, they are readily accessible, and they contain wastes which by their very nature cannot be reliably contained under the most favorable conditions. Further evaluation of this hot spot prior to issuance of the OU 1 Proposed Plan is warranted so that appropriate response actions can be incorporated into the plan and, following public comment, into the ROD.
